ADVANCED COMPOSITE ELEVATOR FOR BOEING 727 AIRCRAFT VOLUME 2—FINAL REPORT

Boeing Commercial Airplane Company
P.O. Box 3707, Seattle, WA 98124

CONTRACT NAS1-14952
NOVEMBER 1980

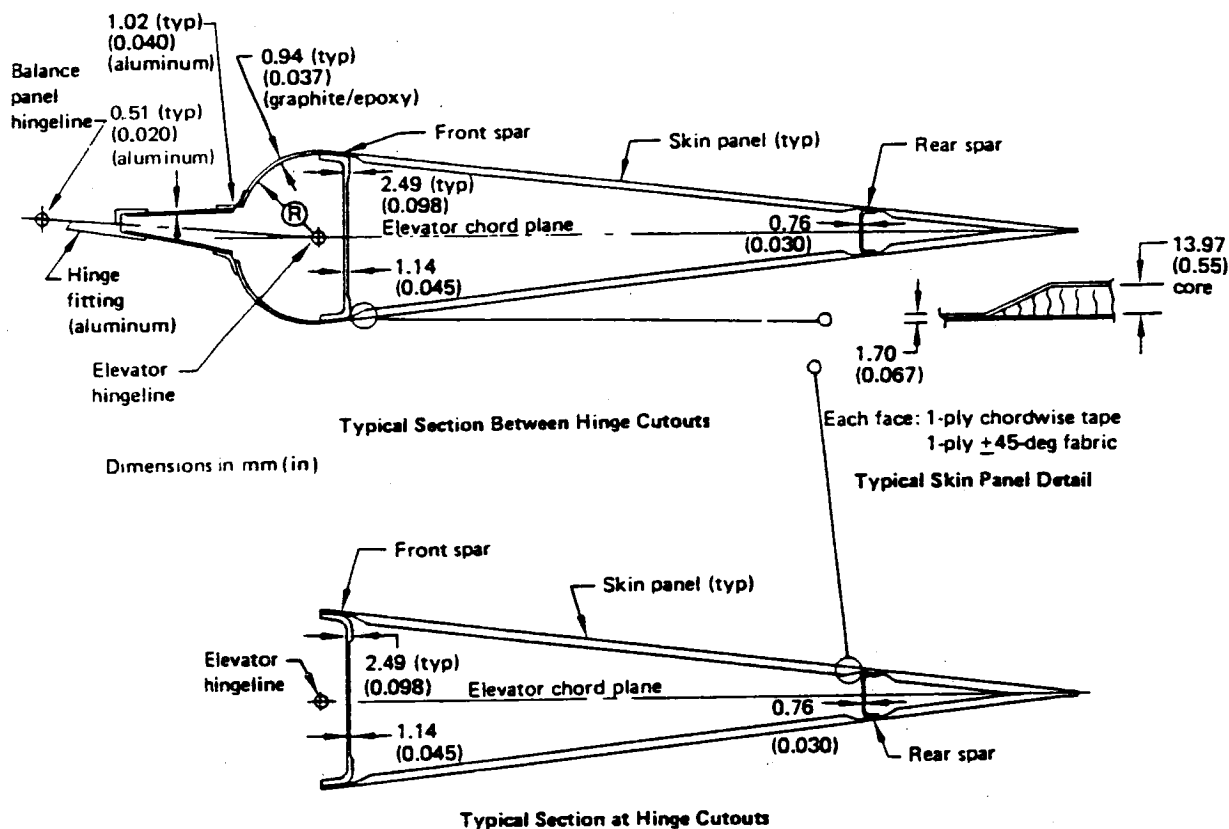
Figure 25. Graphite-Epoxy Composite Elevator

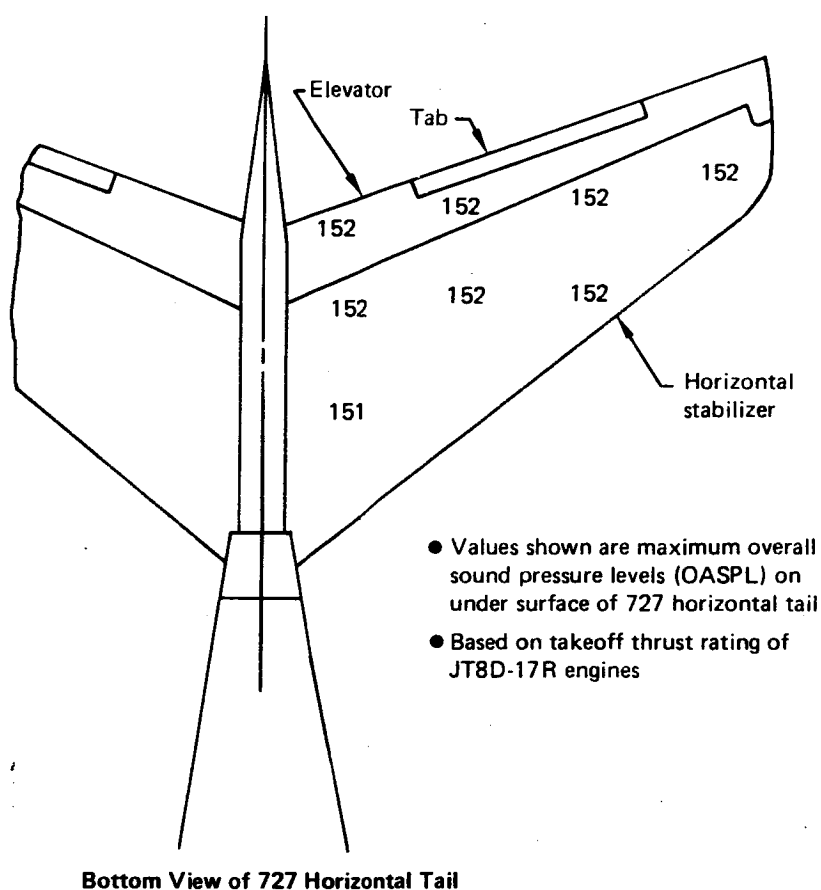
Figure 26. Maximum Overall Sound Pressure Level on 727 Horizontal Tail

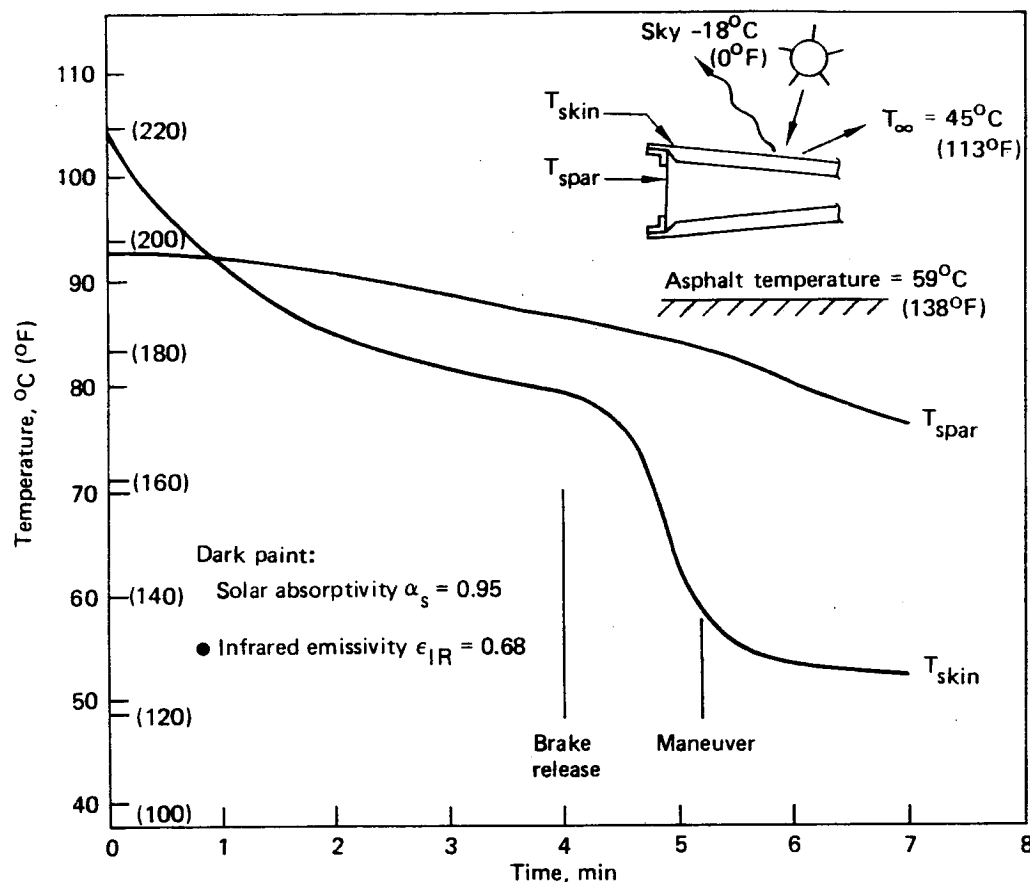
Figure 27. 727 Elevator Thermal Analysis Results

transient analysis were defined as 4-minute taxi run, with a constant relative wind velocity of 37.1 km/hr (20 kn), followed by constant takeoff, acceleration, and climb to 352 km/hr (190 kn) in 1.2 minutes. This point was selected as the earliest possible time that the aircraft could be subjected to significant maneuver or gust loads and would occur at 5.2 minutes after brake release (fig. 27). The ultimate load conditions were conservatively analyzed at this speed and altitude.

The thermal analysis indicated that at the end of 1.2 minutes of flight, the elevator front spar web would be at 82°C (180°F). This temperature was conservatively used for all elevator structure.

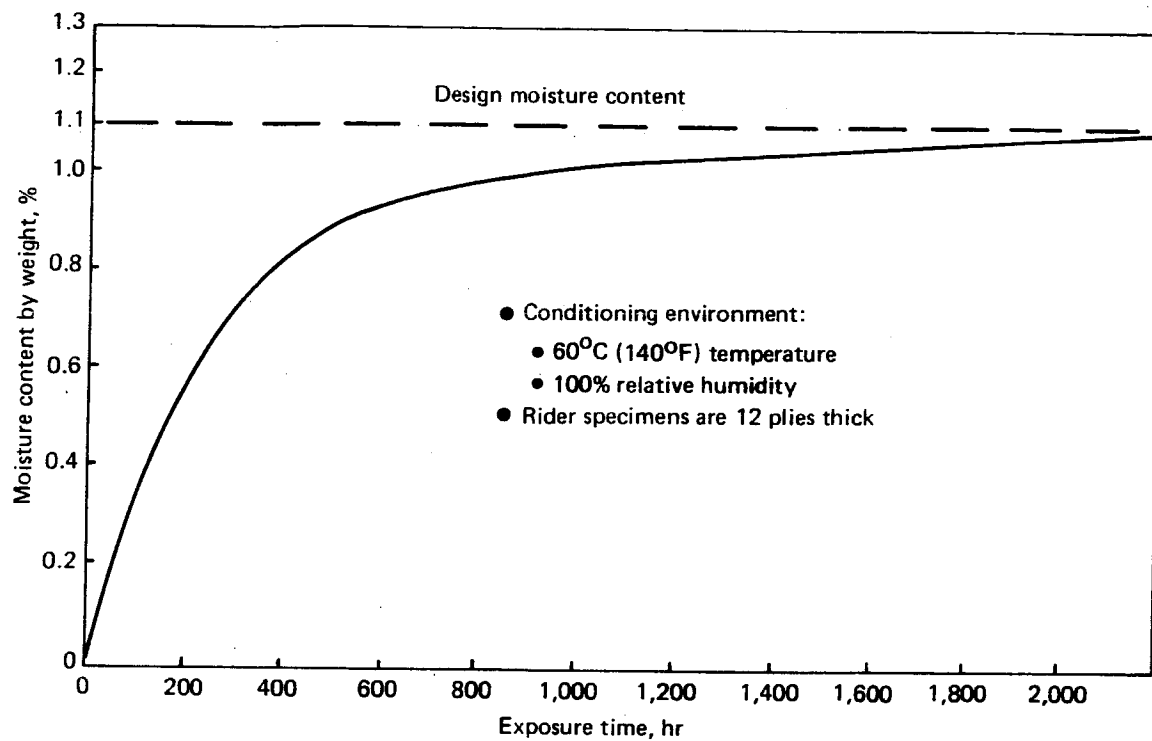
Figure 28. Exposure Time Versus Moisture Content for Laminates

To provide a control for moisture-conditioned test parts in the ancillary test program, a moisture rider coupon was used. The laminate moisture rider was a 12-ply fabric laminate and the honeycomb rider was a two-ply laminate of the same configuration as the elevator skins. These moisture riders were calibrated by placing them in a humidity chamber at 100% relative humidity and 60°C (140°F). Typical weight-gain curves for the 12-ply laminate and honeycomb skin laminate are shown in Figures 28 and 29, respectively. These tests were used to establish typical moisture pickup rates.

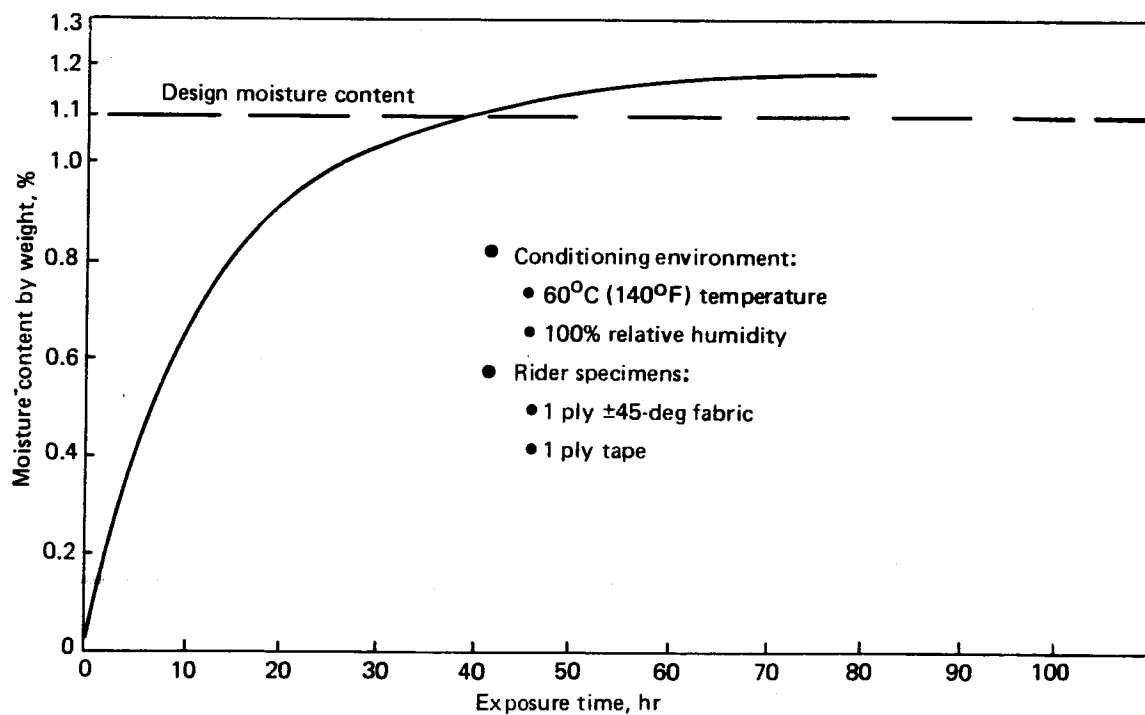
Figure 29. Exposure Time Versus Moisture Content for Sandwich Skin Panel Face

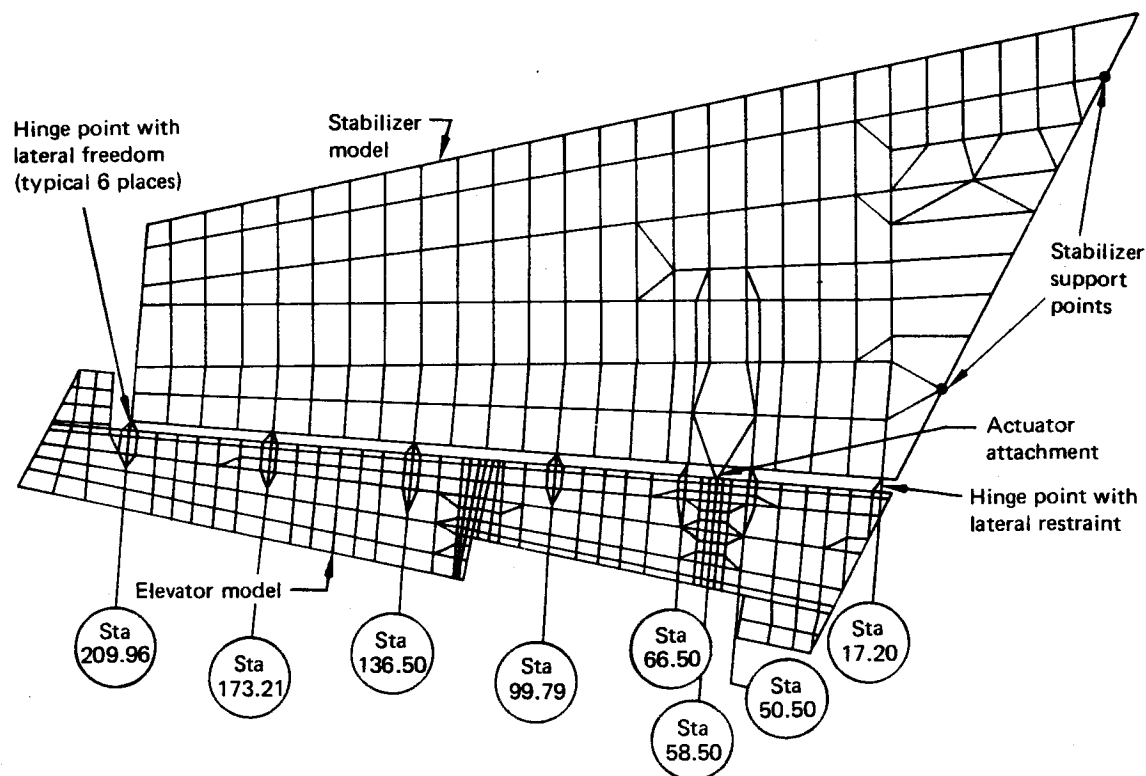
Figure 30. Elevator/Stabilizer Finite Element Model

The hinge attachment points were modeled to produce the required rotational and translational freedoms. The hinge supporting structure at station 17.2 (see fig. 30) was modeled to provide a lateral restraint.

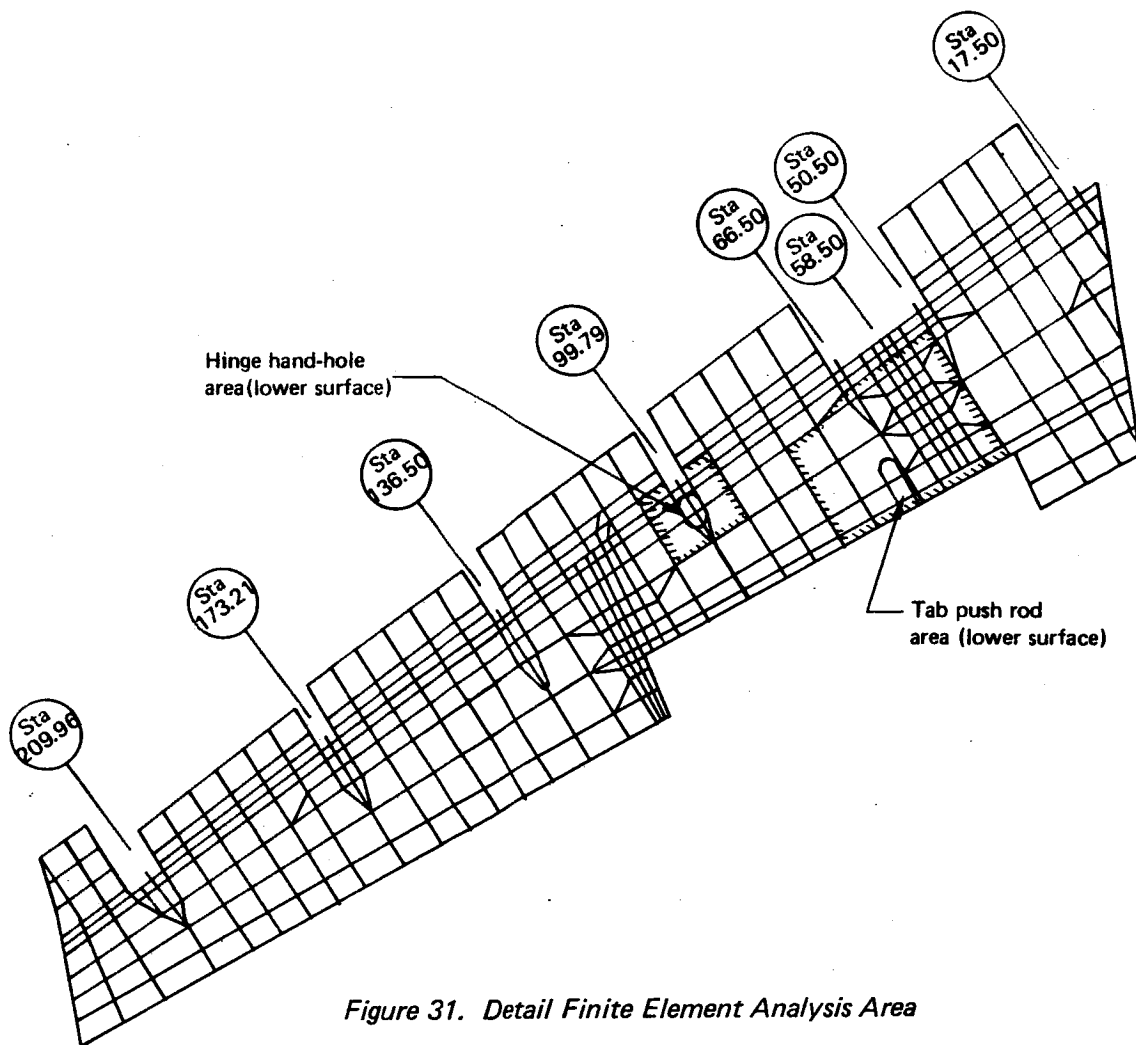
Figure 31. Detail Finite Element Analysis Area

In addition to the overall elevator model, models of the tab rod cutout and hinge hand-hole areas (shown in fig. 31) were developed for detailed analysis of these areas on the lower surface.

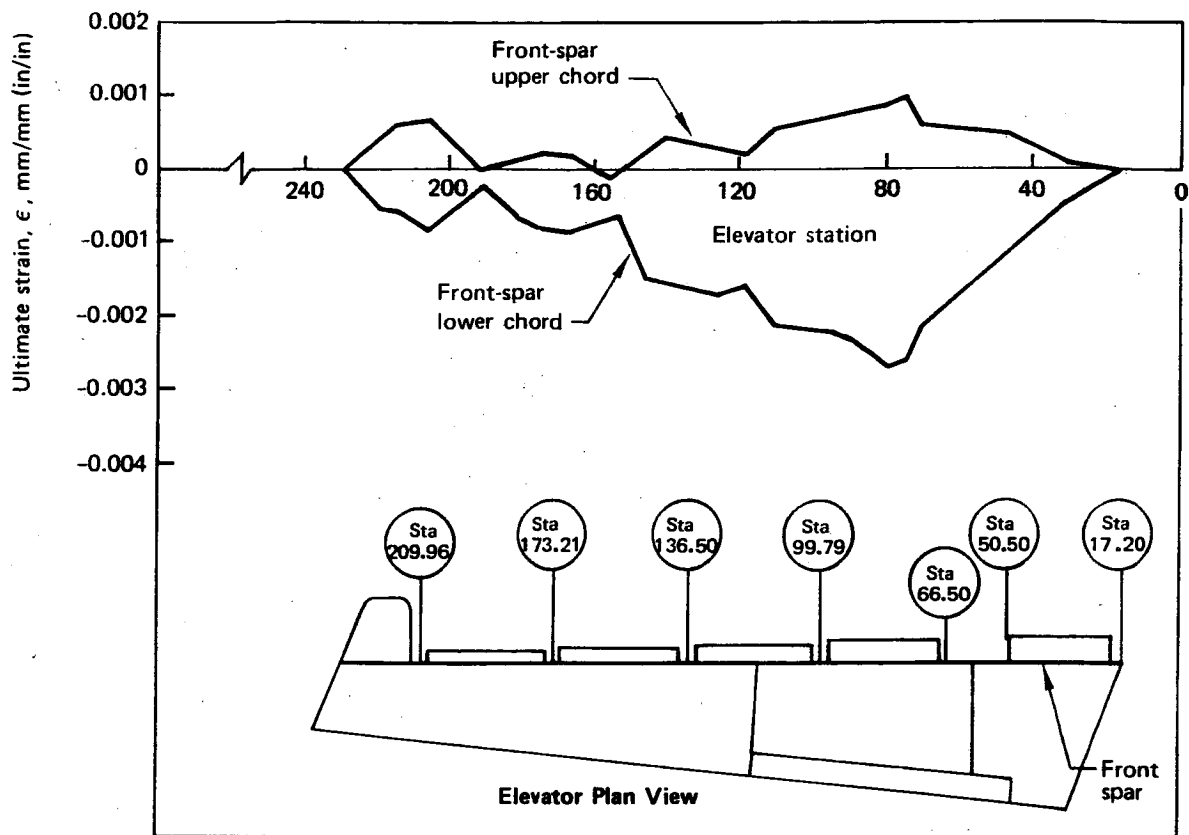
Figure 32. Front-Spar Chord Strains for Load Case 125

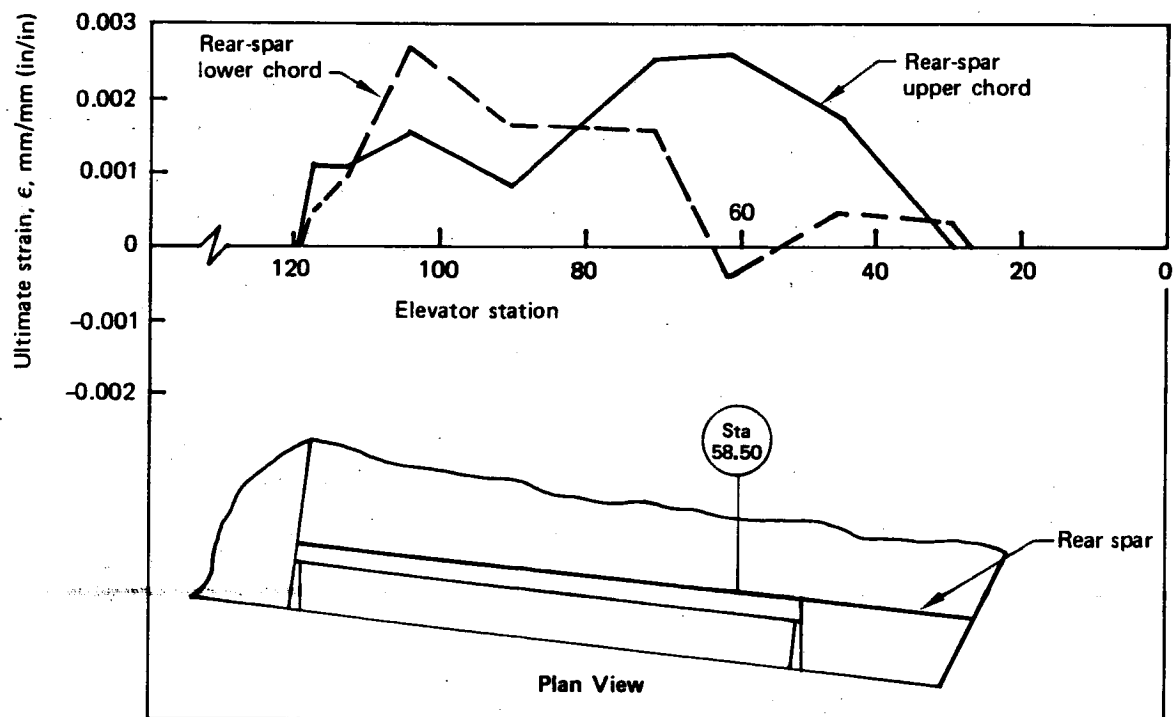
Figure 33. Rear-Spar Chord Strains for Load Case 125

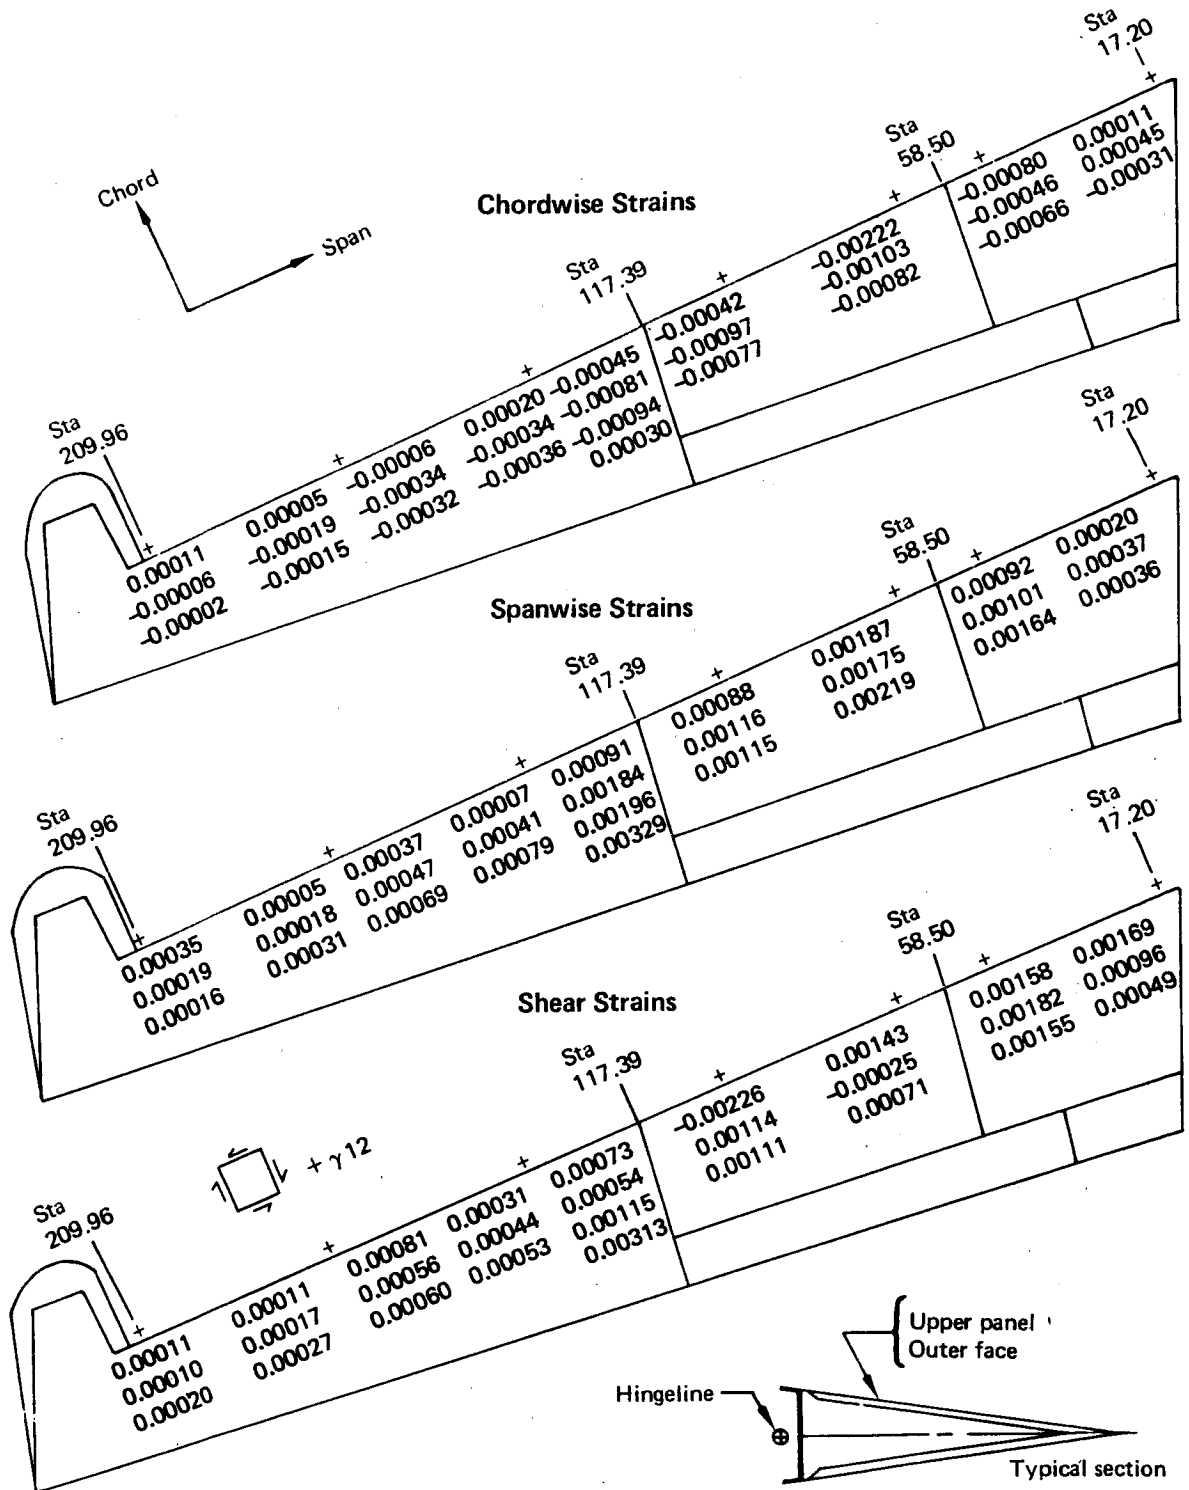
Figure 34. Ultimate Skin Panel Strains, Load Case 125

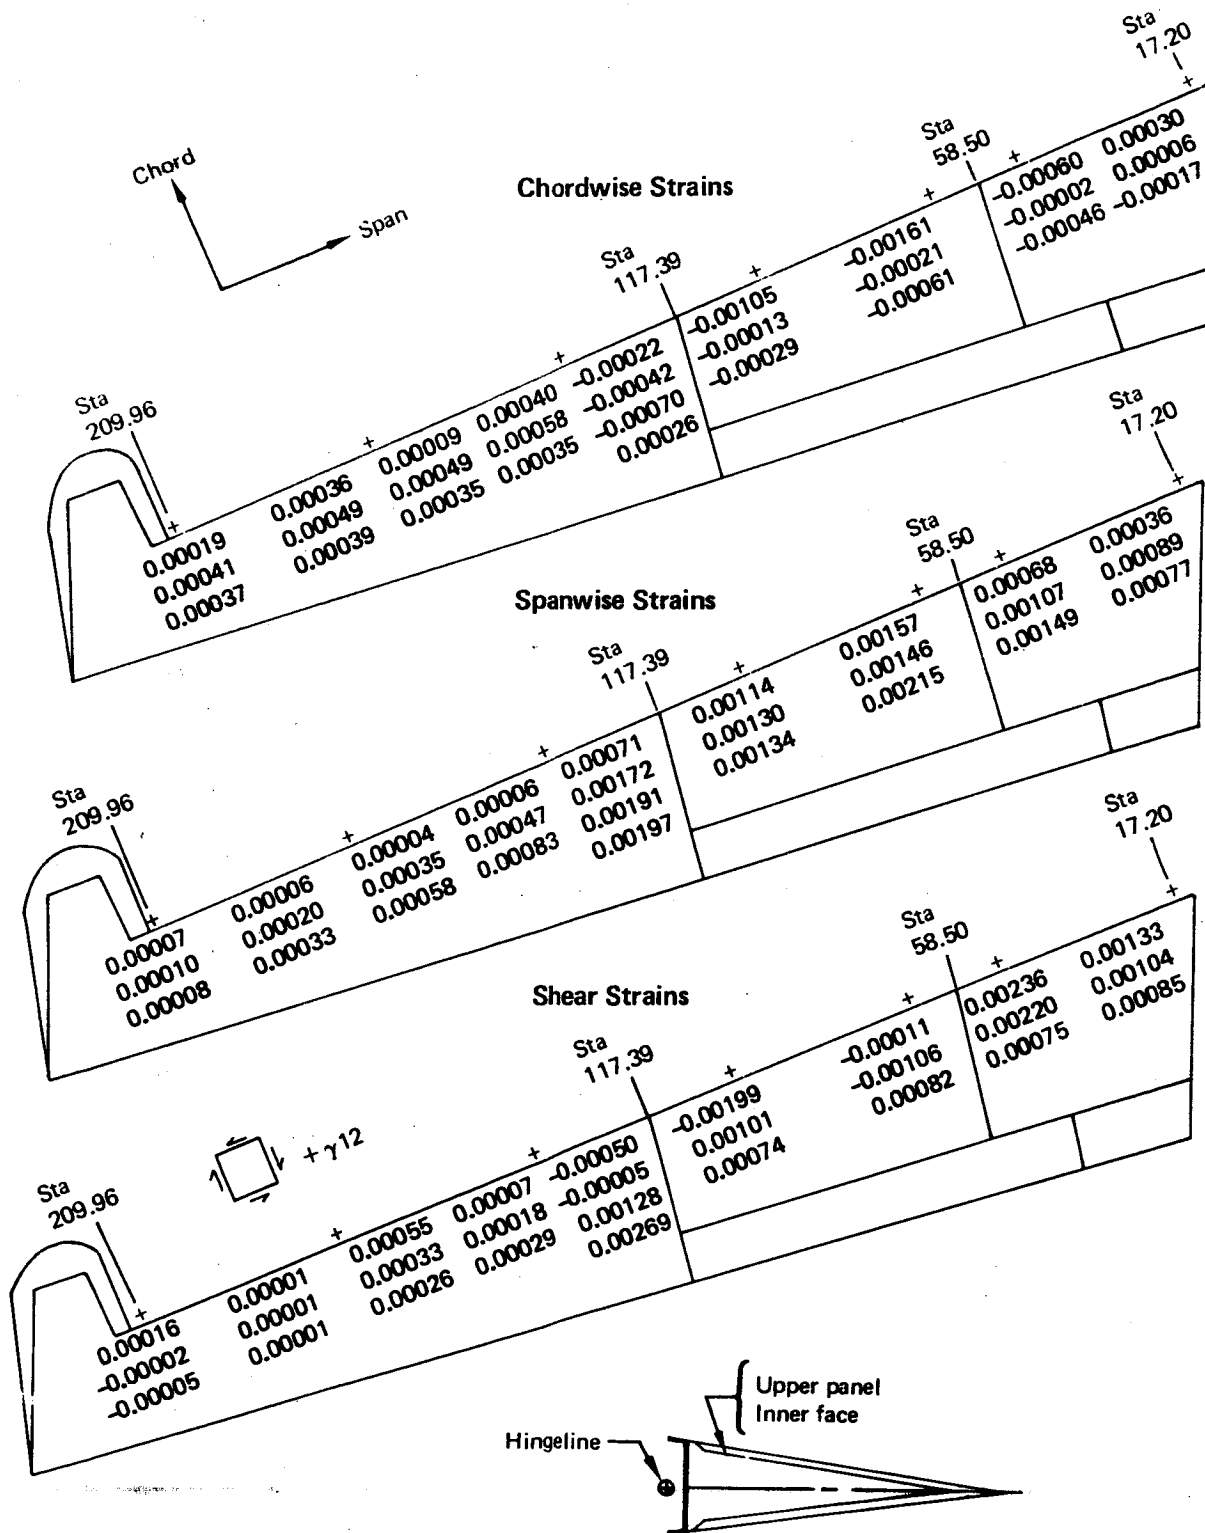
Figure 35. Ultimate Skin Panel Strains, Load Case 125

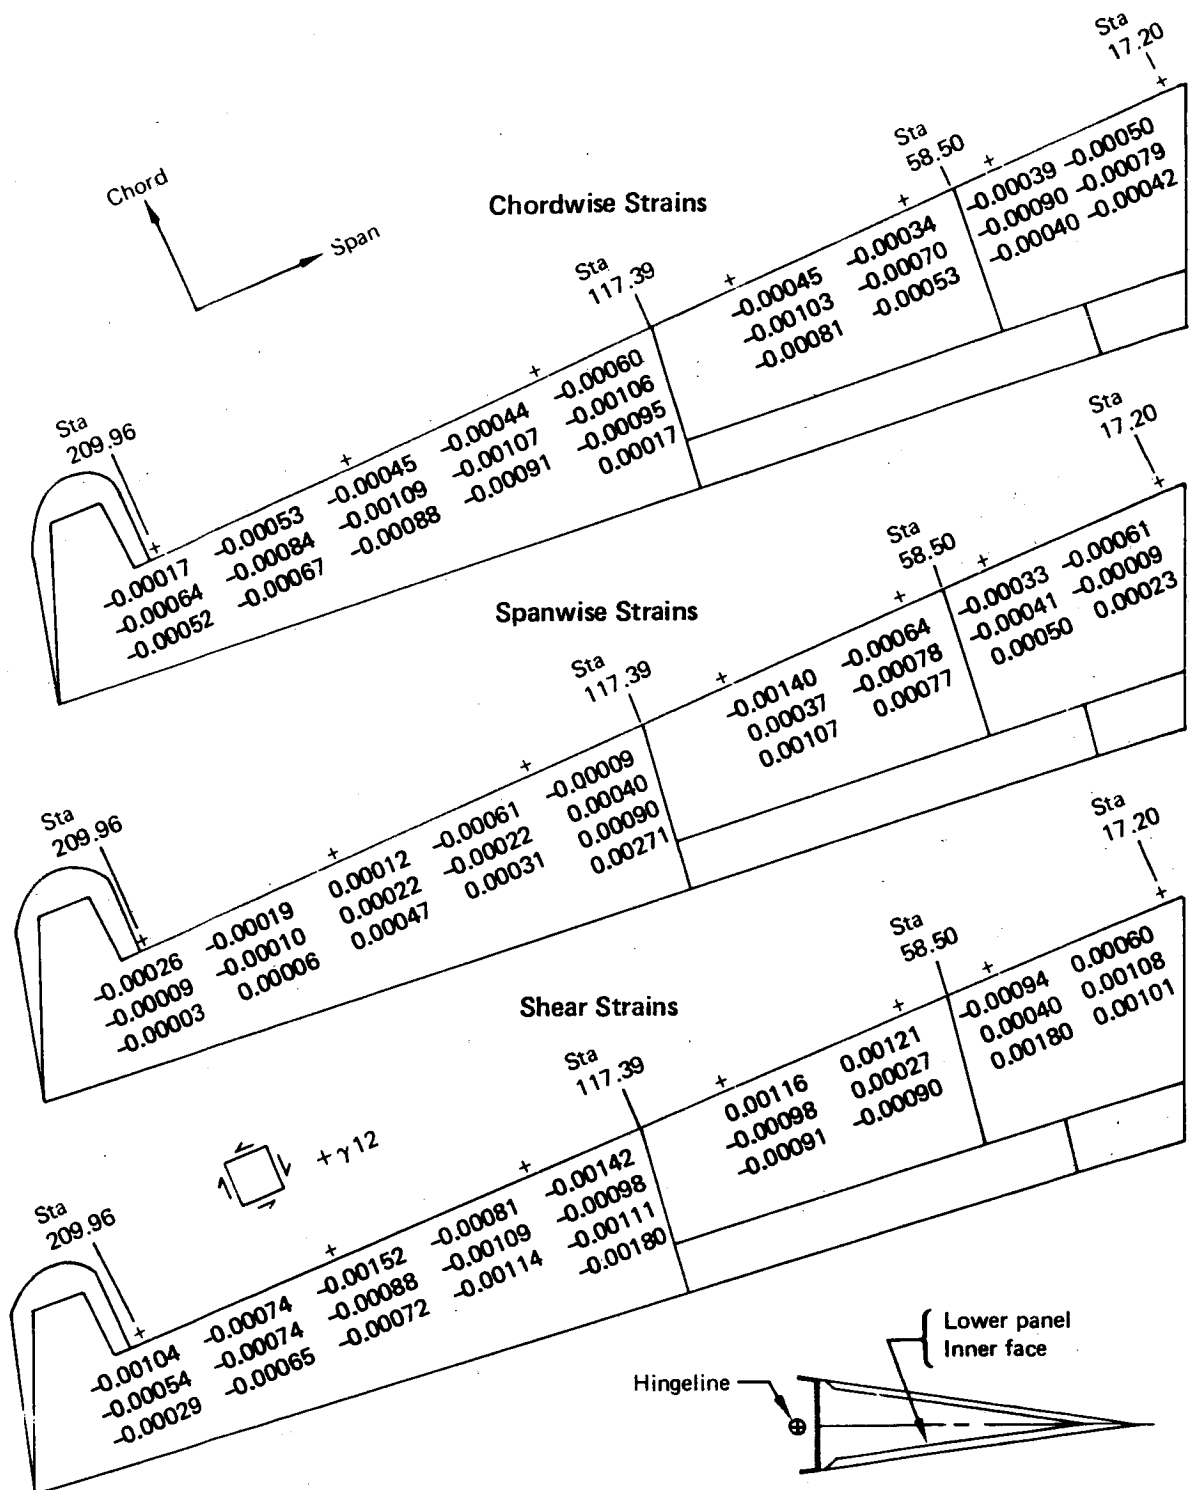
Figure 36. Ultimate Skin Panel Strains, Load Case 125

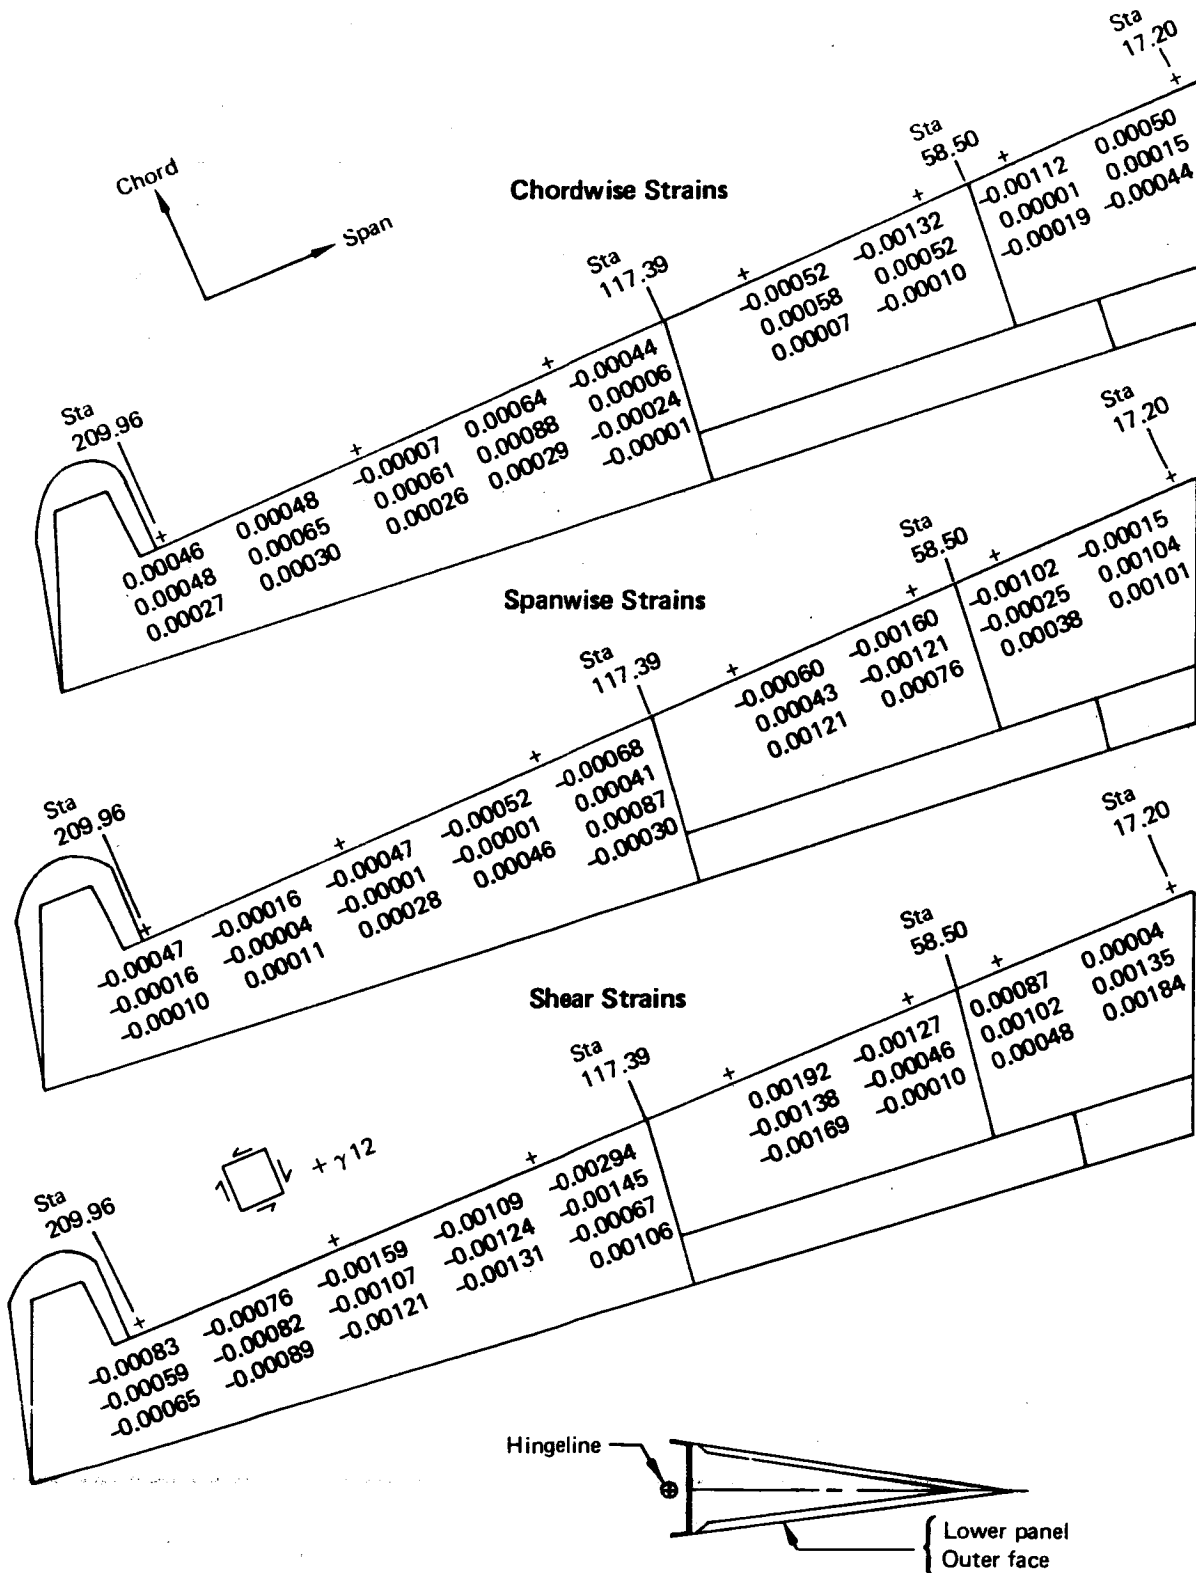
Figure 37. Ultimate Skin Panel Strains, Load Case 125

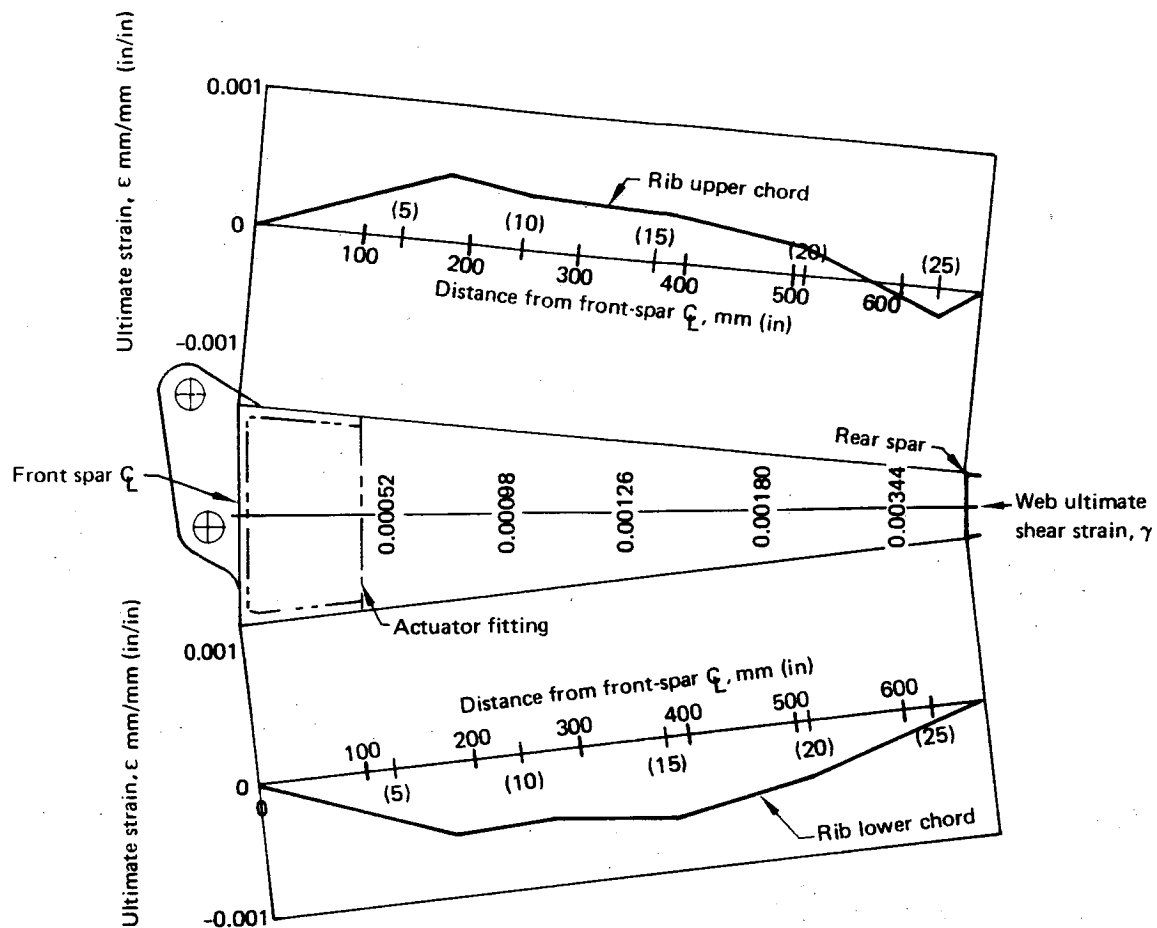
Figure 38. Actuator Rib Strains for Load Case 125.

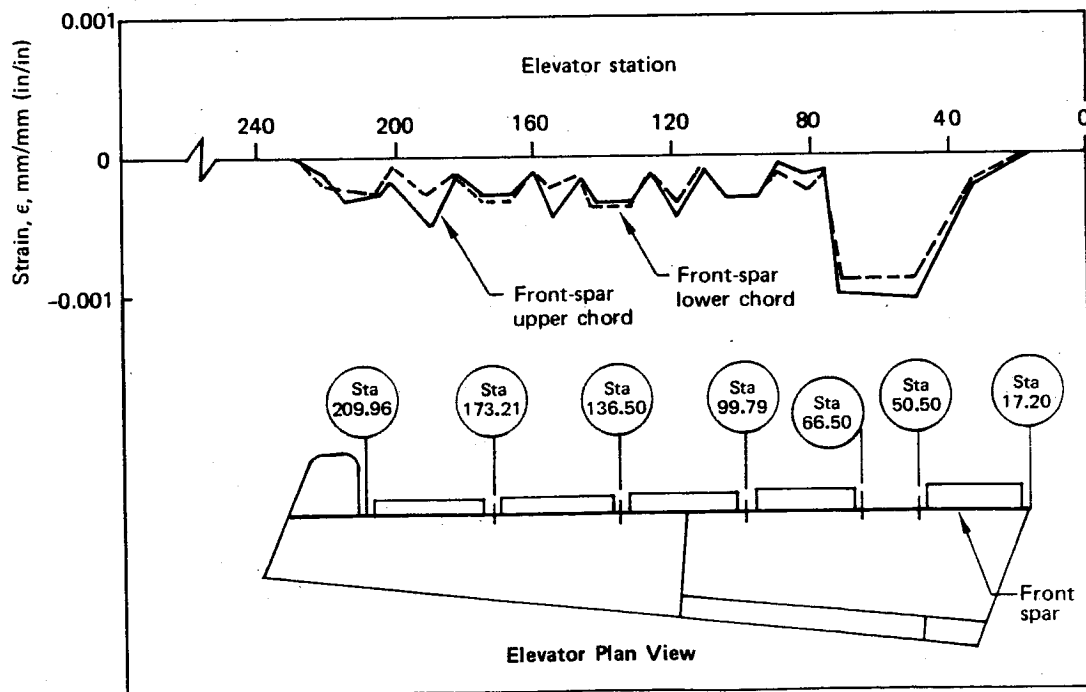
Figure 39. Front-Spar Chord Thermal Strains at -59°C (-75°F), $\Delta T = -81^{\circ}\text{C}$ (-145°F)

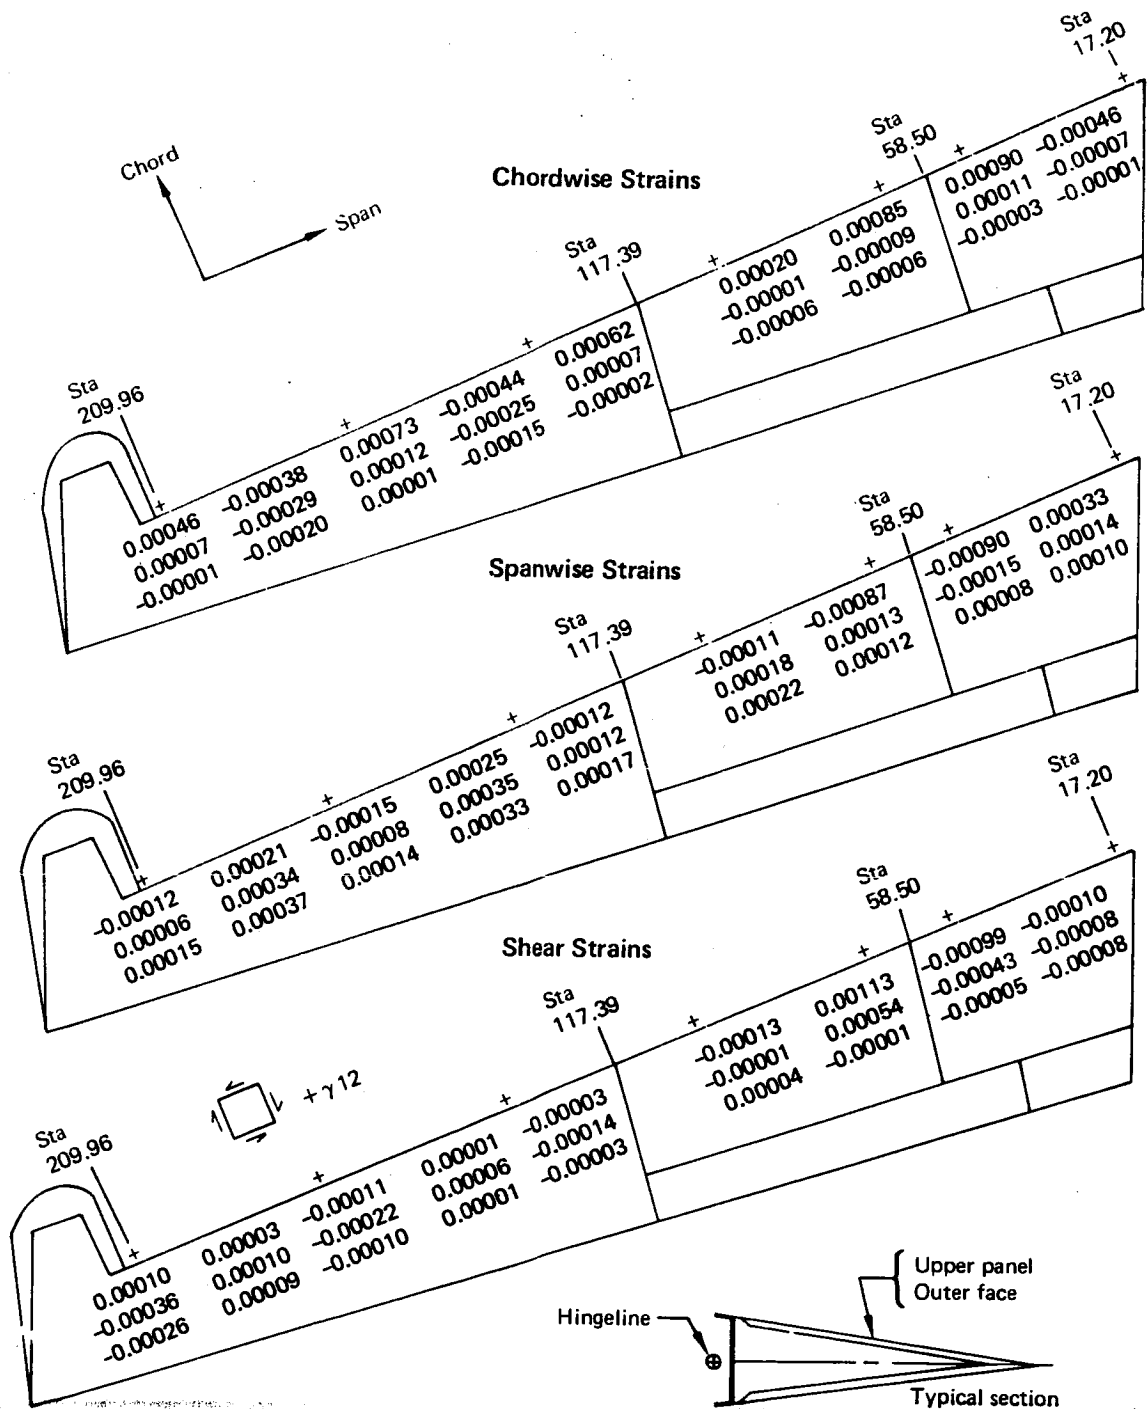
Figure 40. Skin Panel Strains, Thermal Load Case $\Delta T = -81^{\circ}\text{C} (-145^{\circ}\text{F})$
($T = -59^{\circ}\text{C} (-75^{\circ}\text{F})$)

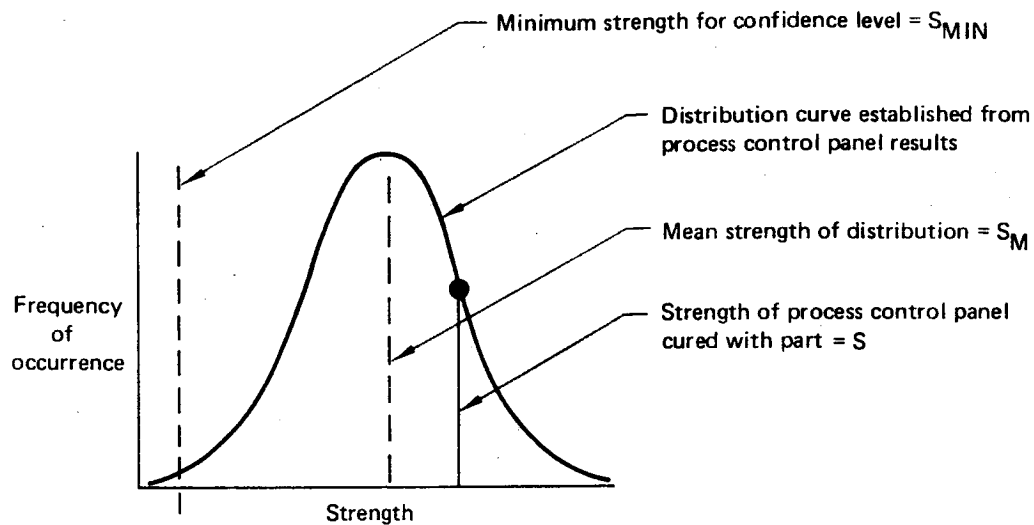
- Material correction factor $MCF = \frac{S_M}{S}$
- Material variation factor $MVF = \frac{S_{MIN}}{S_M}$

Figure 41. Material Strength Correction Factors

Material strength correction factors for each test condition were based on process control test results. Process control panel data were collected from the ancillary test program specimens and analyzed to establish the strength variations. A material correction factor (MCF) was used to correct each test point to the mean of the process panel population and a second factor (MVF) was used to correct the mean value to the required confidence level. These factors are illustrated in Figure 41.

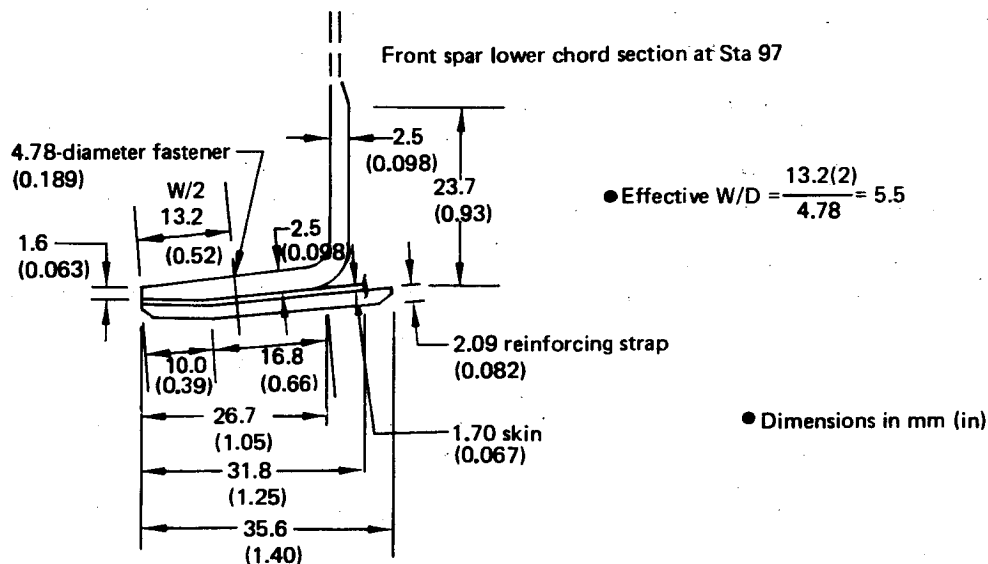
- Strain at section for ambient condition with reinforcing strap included:
 $\epsilon = -0.00321 \text{ mm/mm (in/in)}$
- Lowest margin of safety occurs at 82°C (180°F)
 Thermal strain at 82°C (180°F), $\epsilon_T = 0.000107 \text{ mm/mm (in/in)}$
- Total ultimate strain at 82°C (180°F):
 $\epsilon = -0.00321 + 1.5 (0.000107) = -0.00305 \text{ mm/mm (in/in)}$
- Design value:
 $\epsilon_{DV} = -0.0036 \text{ mm/mm (in/in)}$ for $W/D = 5.5$ at 82°C (180°F) (see fig. 44)
 $MS = \frac{-0.0036}{-0.00305} - 1 = \underline{+0.18}$

Figure 43. Strength Analysis of Front-Spar Lower Chord—Station 97 for LC 125 at 82°C (180°F)

The analysis procedure to define the final margins of safety for the front spar lower chord is shown in Figure 43 and a display of the design values for this detail is shown in Figure 44.

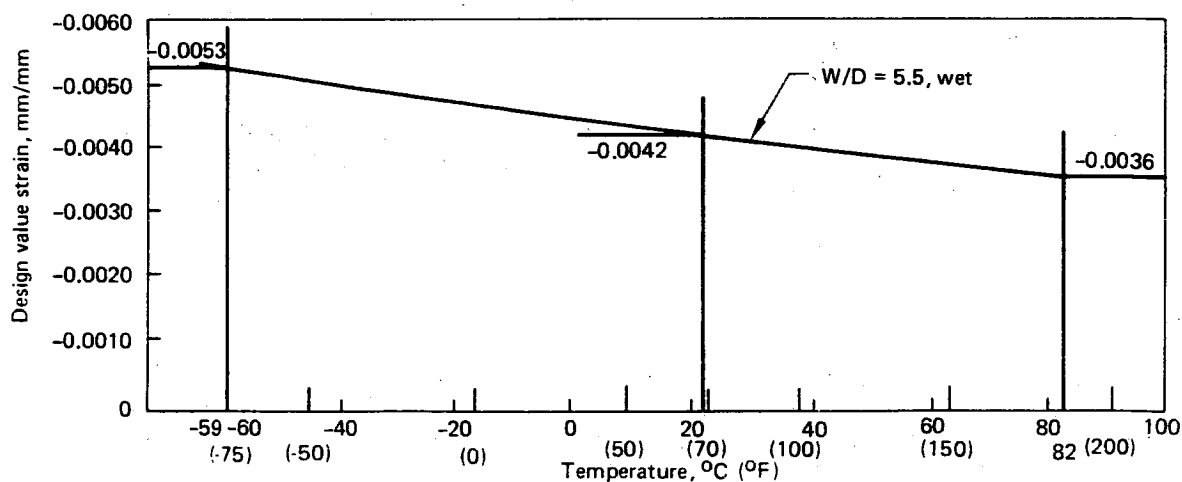
- Data from open-hole coupon tests (see fig. 57)
- DVR of 0.77 used to reduce test data to B basis

Figure 44. Design Value Compression Strain Versus Temperature

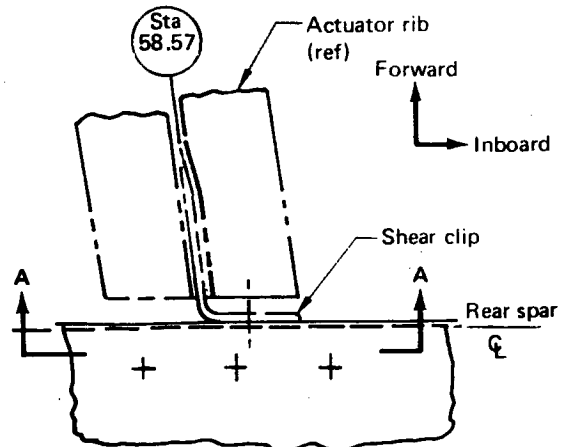
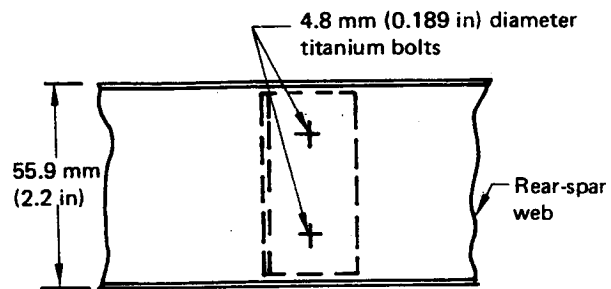
Plan View

Section A-A

1 Critical shear flow from actuator rib web

Figure 46. Strength Analysis of Actuator Rib-to-Rear Attachment for LC 128 at 82°C (180°F)

Actuator Rib-to-Rear Spar Web Attachment—The critical fastener bearing stress in the actuator rib occurs at the attachment of the rib to the rear spar web. The critical condition is LC 128 at 82°C (180°F) and the analysis is shown in Figure 46.

The design value bearing stress at 82°C (180°F) was obtained from the ancillary test structural element tests (see fig. 68, sec. 4.2.3.1). A DVR of 0.74 was used to reduce the test data to the "B" basis.

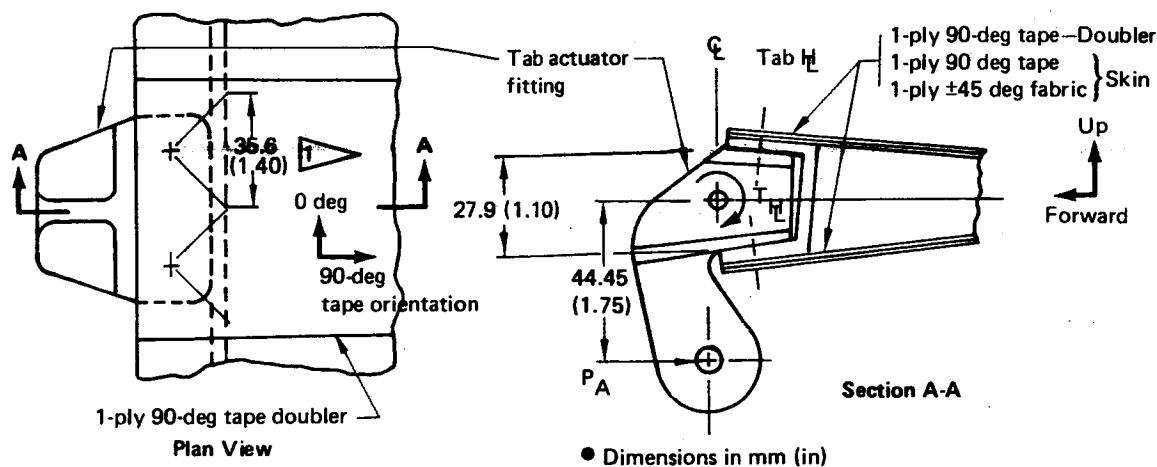
• Critical load: load case 129

$$T_H = 113 \text{ kN} \cdot \text{mm ultimate (1000 in-lbf)}$$

2 Minimum design value at 82°C (180°F)

Figure 47. Strength Analysis of Tab Skin at Actuator Fitting for LC 129 at 82°C (180°F)

Tab Actuator Fitting Attachment—The strength analysis of the tab skin in the region of the actuator fitting is shown in Figure 47. The design value used for the skin laminate is the same as that used for the skin panel analysis (see fig. 45).
